**Baseline survey and design of the traditional core area of Ilaro, Nigeria**

**Thomas A. Ashaolu** (Lead Researcher & Corresponding Author)<sup>1</sup>,

### **Abstract**

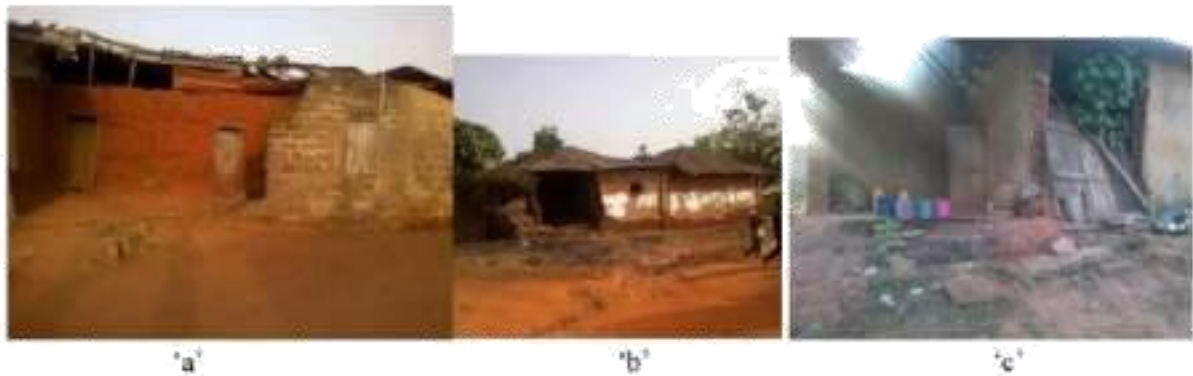
*Plate 2: Collapsing Structures that are still dwelling homes (including 'c' with internal weeds).*

Many dwelling units within the study area were in different stages of total or partial collapse, though still being occupied in their derelict conditions (See Plate 2 for typical dwelling units). Living in such structures is indicative of the level of poverty with the occupants under danger of imminent collapsing shelter while being highly vulnerable to infestations from insects and reptiles. Incidentally, most occupants of such units are the elderly.

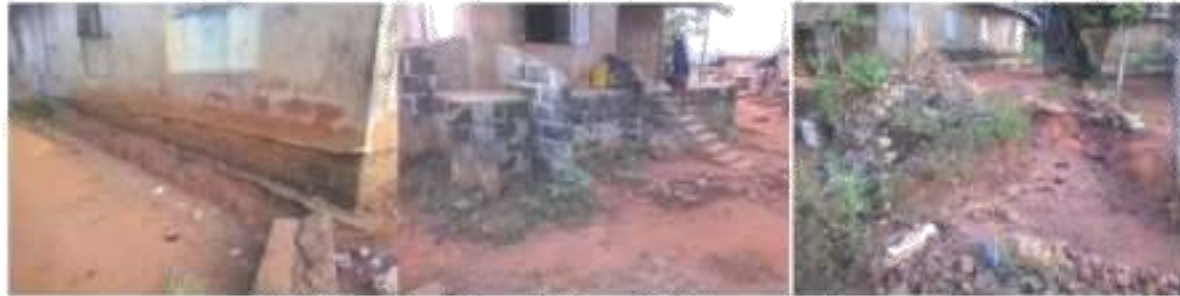
This is the most apparent environmental menace confronting this core area. Many of the access routes have been washed off. The few drain channels along the motorable service roads within the area have either collapsed or blocked with piles of un-cleared refuse. It was also discovered that several buildings had been lost to the spate of gully erosion while the foundation of many others have been weakened by the attack.

'a' (foundation fully exposed)      'b' (protecting structure from wash off)      'c'

*Plate 3: The menace of erosion across different parts of study area*

and Ndoji Road respectively, there is no provision for drainage across the settlement, with one along Ona Osi Street virtually collapsed and in dis-use. Rather, there is free flow of erosion digging up the few available access routes while most of the mud houses have been caving in to persistent attacks on their foundation by swift-running erosion.

Accordingly, as shown in proposed design, the team has identified plausible courses for channeling rainwater across the settlements, taking advantage of the natural slope towards UAMC/Ibikunle Road. A total of three courses have been earmarked for construction and are edged in blue colour in the figures.

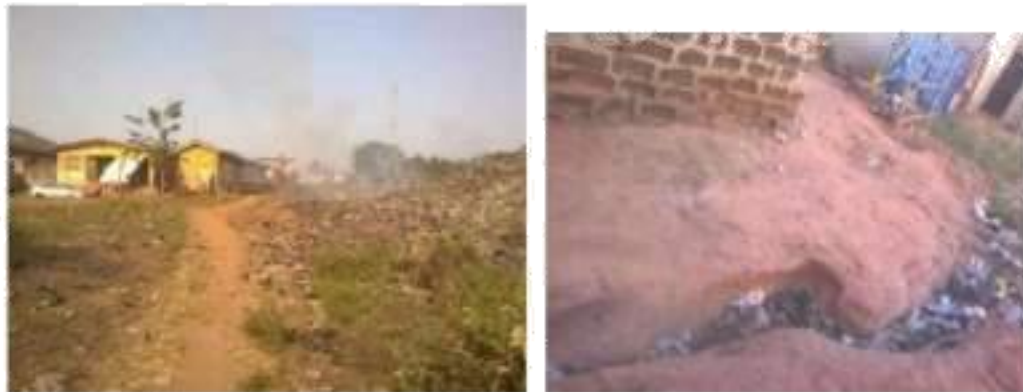
The area was found to be generally filthy and unkempt. A major cause of this is the location of a refuse dump at the central portion of the built-up area which contents were being spread to litter the streets and open spaces by breeze. Invariably, the refuse site with adjoining fallow parcel of land have provided haven for rodents, mice and reptiles that regularly infest neighbouring dwellings. Occasionally, the dump is set on fire thereby further releasing obnoxious fumes across the area. See Plate 4.

a      b  
*Plate. 4: Heap of Refuse at the Igbo Ewe site (central portion of study area) in 'a', while 'b' depicts typical erosion course converted to refuse dump in Ona Osi Quarters*

The existing refuse dumpsite is to be evacuated to a location to be agreed with the Yewa Local Government Council, preferably in the outskirt of the township. The smaller dumps near the dwellings around Ona-Osi Quarters (being undeveloped plots now converted) would also be cleared and discouraged from further usage. As replacement, solid waste shall be organized to be disposed into plastic drums to be collected on weekly basis at a self-sustaining cost. A disposal van would have to be procured for this purpose. The Ogun State Government would be formally requested to as a matter of urgency, fence up their un-utilised Jubilee Estate land that has remained hazardous and security-risk to residents of the neighbourhood.

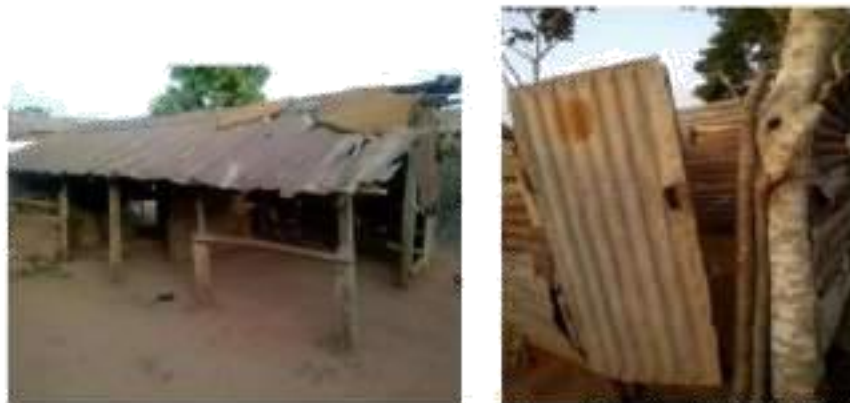
Toilets and bathrooms are typical necessities in any living environment. Most of the residents have external toilets of pit latrine type while bathrooms are often built with old, make-shift corrugated sheets that seldom afford complete privacy. Plate 5 depicts a sample found on site.

*Plate 5: A set of make-shift Kitchen and Bathroom within the study area*

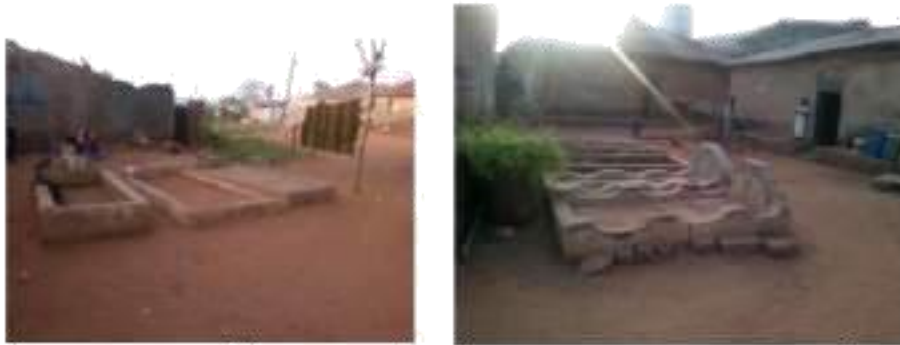
A notable cultural practice in the study area is the prevalence of burial tombs within and around dwelling units. See Plate 6. This would not only emphasise the endowment effects that limits transferability of landed property by outright disposal but also constitutes one social factor against clearance and conventional urban renewal programmes. Unfortunately also, the area can only source potable water from wells and boreholes that are dug within seeping lengths from these tombs.

*Plate 6: Typical Tombs Around Dwelling Units*

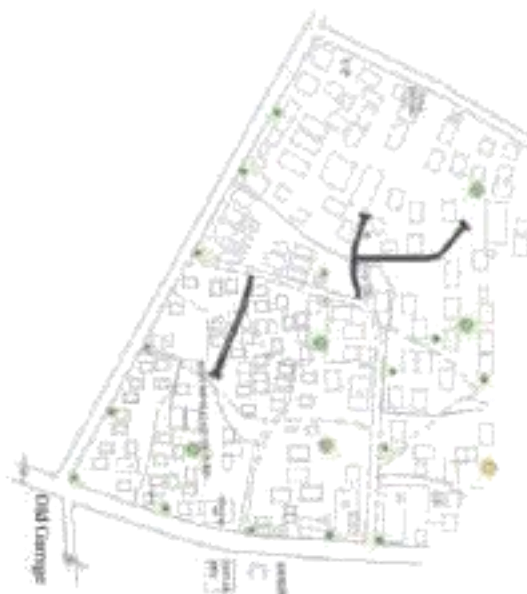
*Plate 7: Ona Osi zone of the study area depicting proposed Roads (thick black)*

Many premises were found not to have defined access and in some cases, a whole compound of houses lack vehicular access from distant lateral routes. By taking points of least resistance, and following existing footpaths, four roadways have been introduced, often ending in 'cul de sac' to provide vehicular access as close as practicable to each dwelling. All other existing roadways are to be upgraded and tarred. See example in Plate 7 for Ona Osi Zone.

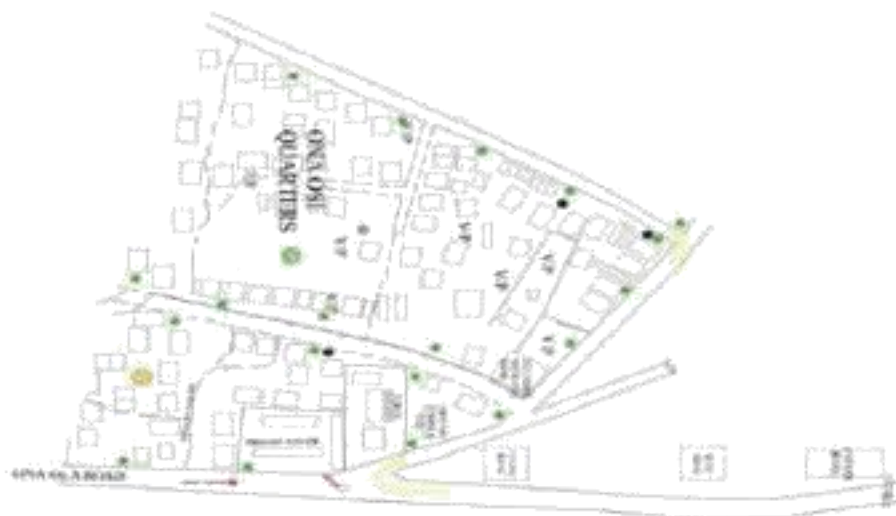
**Plate 8:** *Proposed Traffic Diversion at Jubilee Estate/Union Bank Junction*

The Olu of Ilaro and paramount ruler of Yewaland in a correspondence to our team however requested that the traffic gridlock gradually developing along the Ona-Ola Road from the Jubilee Estate/Union Bank Round about towards Post Office be looked into with a view to 'turning some of this road one way'. In this light, our team identified the feasibility of making the narrow portion of Ona-Ola Road a one-way traffic from the old Garage junction onto Jubilee Estate/Union Bank Roundabout while traffic from this point towards old Garage would be diverted through Egbo Road onto Igbo Ewe Road, linking UAMC/Tunde Ibikunle Road with a roundabout created on this latter Road to receive the oncoming traffic (See Plate 8 and the Proposed design in Appendix for details).
